SUSQUEHANNA RIVER BASIN
ANDERSON CREEK, CLEARFIELD COUNTY
PENNSYLVANIA

DuBOIS RESERVOIR
NDI No. Pa. - 424

PHASE I INSPECTION REPORT
NATIONAL DAM INSPECTION PROGRAM

PREPARED BY
GAI CONSULTANTS, INC.
570 BEATTY ROAD
MONROEVILLE, PENNSYLVANIA 15146
AUGUST 1978

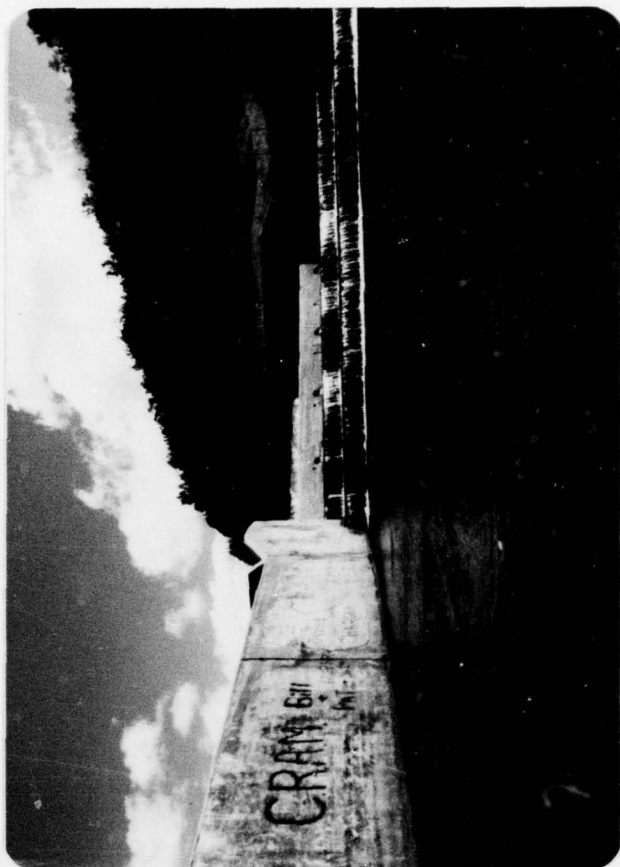
1. Spillway. The spillway, spillway sidewalls, and apron all appeared to be in fair condition. Some scaling was observed over the entire structure; however, the deterioration was not considered excessive. Some etching of the construction joint at the intersection of the apron and spillway wingwall was evident (see Photograph 9). This condition is considered deleterious since there is no water stop at this joint and the reinforcing steel could eventually corrode. According to Mr. Hoffer (city engineer) they are planning to gunnite the spillway as well as the concrete paving on the upstream face of the dam.

b. Appurtenant Structures. Based on visual observations and past history, the spillway appeared to be in fair condition. However, two major detrimental items were noted concerning the spillway. The first is that water discharging through the spillway has etched its way behind the construction joint at the intersection of the spillway apron and spillway side wall (see Photograph 9). This condition is considered serious in that water stops may not have been provided during construction; thus, the reinforcing steel connecting the spillway sidewalls to the floor slabs may be subject to corrosion (particularly if exposed by the etching action). If unchecked, corrosion of the connecting steel could lead to undesirable wall movements or structural failure of the sidewalls from lateral earth pressures.

PHOTOGRAPH 7 View of the chute spillway at DuBois Reservoir. The ogee crest is visible in the background of the photograph.

2) take measures to insure that the concrete spillway apron slabs remain in place during periods of high flow and seal the construction joints between the spillway sidewalls and apron so that water cannot flow into the joint and corrode the reinforcing steel.

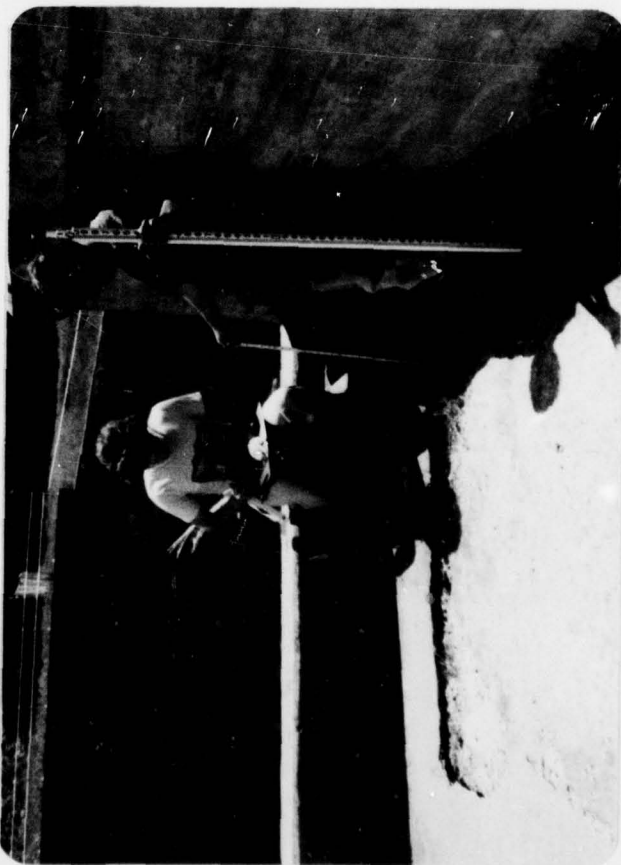
Settlement was noted in the concrete paving adjacent to the right spillway wingwall and gate house. Vertical displacements measured approximately 6 inches. The condition may be a result of poor compaction around the gate house and the old spillway which was apparently left in place when the embankment was modified in 1936.

Some settlement (6 inches) was noted in the concrete paving atop the crest of the dam adjacent to the spillway wingwall (see Photograph 6) and gate house. This condition may be related to the fact that they incorporated the original spillway into the existing embankment when the dam was raised in 1936 and the inherent difficulty in compacting soil against walls.

Rip-rap consists of concrete slabs which originate below the water level and continue up to the concrete cut-off wall at the dam crest. Visual inspection revealed this concrete face to be in fair condition with spalling and cracking evident. In addition, considerable settlement (approx. 6 in) is visible in the slab located adjacent to the spillway.

PHOTOGRAPH 6 Close-up view of cracking and settlement on the crest of the dam near the right wingwall of the spillway.
